**Flood Control Project Maintenance
Levee Inspections**

Fall 2018 Levee Maintenance Deficiency Summary Report

San Joaquin River Basin

Reclamation District No. 2063 Crows Landing

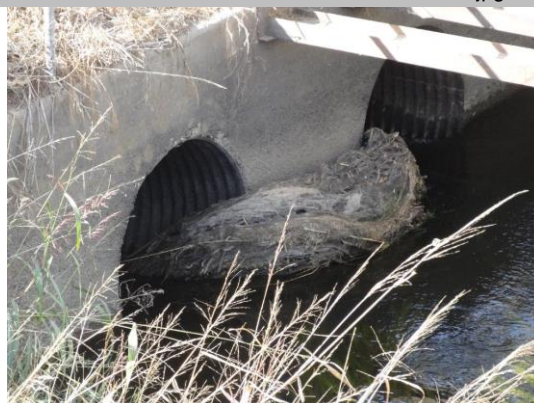
Photo 3 of 3 : UCIP_FA_2018_24650_44000.jpg

LS view: drainage pipes under walkway in drainage ditch.

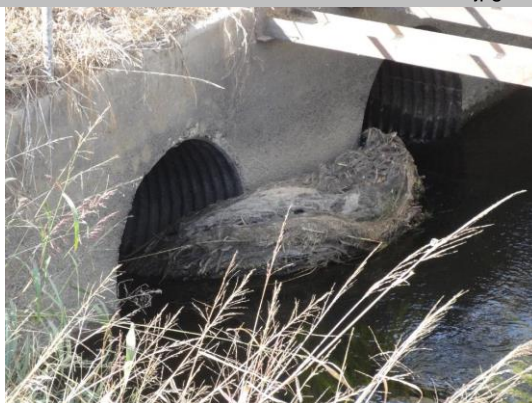
Photo 3 of 3 : UCIP_FA_2018_24636_43963.jpg

LS view: drainage pipes under walkway in drainage ditch.

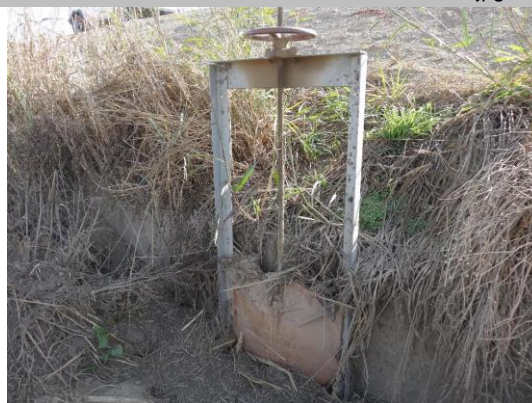
Photo 1 of 2 : UCIP_FA_2018_24638_43967.jpg

Comment Code						
Inspector Comment						
FS_ID:24638						
DS_ID:22114						
EP_NO: N/A						
Repair Type: No Action Needed						
Crossing Status: Found						
UCIP Comments: 11/06/2013 Flap gate and concrete "U" headwall not visible due to dense vegetation on waterside. (P. Amatya - DWR UCIP)						
FIELD_STRUCT_DESC: 24-inch corrugated metal gravity drainage pipe through the levee, 12 feet below the crown. Flap gate, concrete U-shaped headwall, and 7-foot-long grouted spillway on the waterside (WS) end. Slide gate and concrete headwall on the landside (LS) end. Installed by USACE in 1961. [Additional Reference(s): DWR Levee Log, 1992. USACE San Joaquin O&M Manual 6, September 1961, (HLM 9.21)].						
FS Date: 11/6/2013

WS view: concrete headwall on levee end. Slide gate on pipe end.

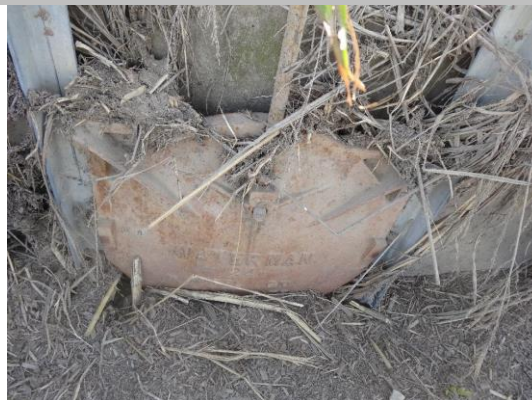
Photo 2 of 2 : UCIP_FA_2018_24638_43966.jpg

WS view: close view of slide gate on pipe end.

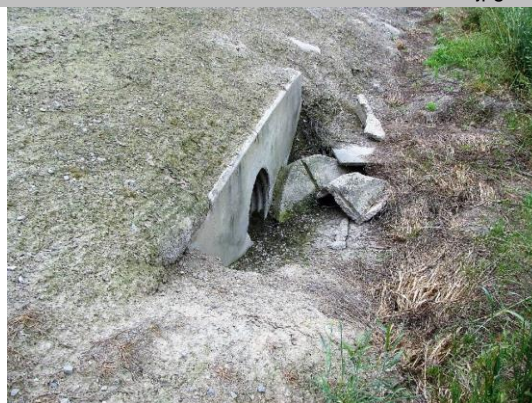
Photo 1 of 3 : UCIP_FA_2018_51825_77044.jpg

Comment Code						
Inspector Comment						
FS_ID:51825						
DS_ID:22115						
EP_NO: N/A						
Repair Type: No Action Needed						
Crossing Status: Found						
UCIP Comments: 04/11/2017 LS inlet has been cleared, as per DWR inspector Richard Willoughby. (K. Fazel - UCIP)11/06/2013 Landside inlet blocked by plywood. (P. Amatya - DWR)						
FIELD_STRUCT_DESC: 24-inch corrugated metal gravity drainage pipe through the levee, 5.6 feet below the crown. Flap gate and concrete U-shaped headwall on the waterside (WS) end. Concrete headwall on the landside (LS) end. Installed by USACE in 1961. [Additional Reference(s): DWR Levee Log, 1992. USACE San Joaquin O&M Manual 6, September 1961, (HLM 9.66)].						
FS Date: 4/11/2017

LS inlet as of 4/11/2017 levee inspection. Photo courtesy of DWR inspector Richard Willoughby.

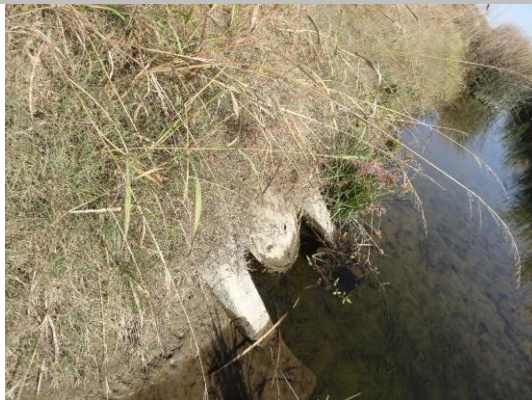
Photo 2 of 3 : UCIP_FA_2018_51825_43983.jpg

WS view: U type headwall and flap gate visible on the bank of the water channel.

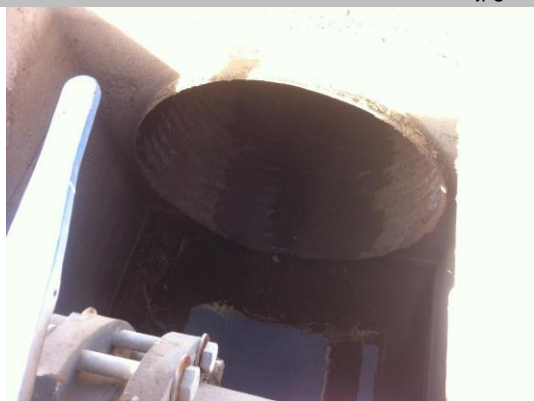
Photo 1 of 3 : UCIP_FA_2018_24644_43986.jpg

Comment Code						
Inspector Comment						
FS_ID:24644						
DS_ID:22116						
EP_NO: N/A						
Repair Type: No Action Needed						
Crossing Status: Found						
UCIP Comments: 11/06/2013 - not very old structure. (P. Amatya - DWR UCIP)						
FIELD_STRUCT_DESC: 48-inch corrugated metal gravity drainage pipe through the levee and across the drainage ditch on the waterside (WS), 6 feet below the crown. Slide gate and concrete box on the WS end. Concrete box on the landside (LS) end. Installed by USACE in 1961. [Additional Reference(s): DWR Levee Log, 1992. USACE San Joaquin O&M Manual 6, September 1961, (HLM 10.11)].						
FS Date: 11/6/2013

WS view: CM pipe on outlet concrete box.

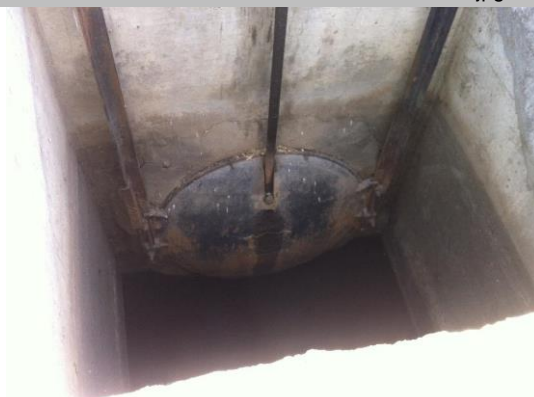
Photo 3 of 3 : UCIP_FA_2018_24644_43984.jpg

LS view: inside view of slide gate in concrete box.

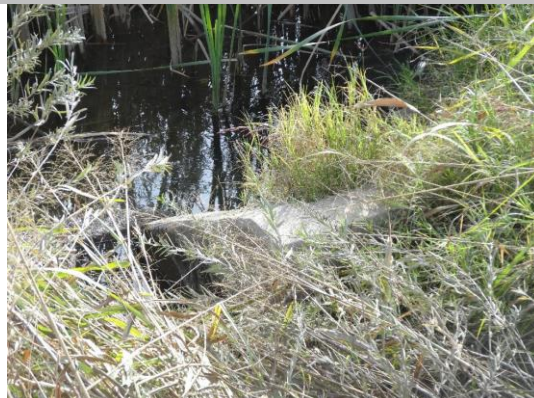
Photo 1 of 2 : UCIP_FA_2018_24645_43988.jpg

LM Start	9.95	Rating **	M	Issue No.	89
LM End	9.95	Issue Type +	Ma	Location *	
Category	Supplemental			GPS Latitude/Longitude	
				Start	End
Item	DWR UCIP LMA Responsibility			37.390572 °	37.390572 °
				-120.950156 °	-120.950156 °
DWR ID	22117				
Comment Code					
Inspector Comment					
FS_ID:24645 DS_ID:22117 EP_NO: N/A Repair Type: Non-Urgent Crossing Status: Found UCIP Comments: 11/06/2013 - waterside not accessible.- partially blocked inlet opening on landside. (P. Amatya - DWR UCIP) FIELD_STRUCT_DESC: 24-inch corrugated metal gravity drainage pipe through the levee, 4.6 feet below the crown. Flap gate and concrete U-shaped headwall on the waterside (WS) end. Concrete headwall on landside (LS) end. Installed by USACE in 1961. [Additional Reference(s): DWR Levee Log, 1992. USACE San Joaquin O&M Manual 6, September 1961, (HLM 10.12)]. FS Date: 11/6/2013

WS view: concrete U type headwall on channel bank. Not accessible.

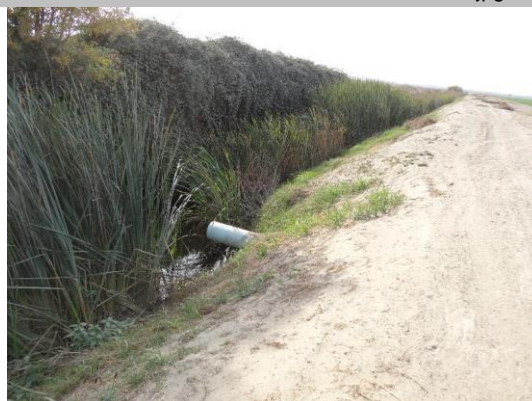
Photo 1 of 3 : UCIP_FA_2018_53095_43990.jpg

Comment Code						
Inspector Comment						
FS_ID:53095 DS_ID:22074 EP_NO: N/A Repair Type: Urgent Crossing Status: Found UCIP Comments: 10/19/2018 Pipe size was field measured and confirmed to be 16 inches. Unable to find any records indicating authorization for this crossing. This crossing appears to be an unauthorized encroachment. Need to contact owner to find out if crossing was authorized through the CVFPB. Surface erosion appears to have gotten worse since last inspection. Levee height at this crossing location is about 5 to 6 feet tall. Outstanding issues that need to be addressed with the CVFPB and owner for this crossing include: crossing appears to an unauthorized encroachment through the levee and surface erosion has increased on LS slope. Crossing remains Urgent due to the increase surface erosion on the LS. (O. Magana - DWR UCIP)09/29/2017 Received updated photos from DWR levee inspector, D. Torres, and photos show a metal cover has been added to landside (LS). The waterside (WS) pipe side remains open. This crossing remains urgent due to the WS end of the pipe open. Other issues with this crossing include compliance issues per Title 23. No permit was found authorizing this crossing. (DWR UCIP - O. Magana)08/23/2016 Same as last inspection. Recommend LMA contact owner to bring crossing into compliance per Title 23. (K. Fazel - UCIP)11/06/2013 Pipe opens on both sides of the levee. (P. Amatya - DWR) FIELD_STRUCT_DESC: 16-inch polyvinyl chloride (PVC) gravity drainage pipe through the levee, 3.5 feet below the crown. Pipe open on both ends. This crossing was field discovered. FS Date: 10/19/2018 11:00:00 AM

WS view: PVC pipe with open end on levee slope.

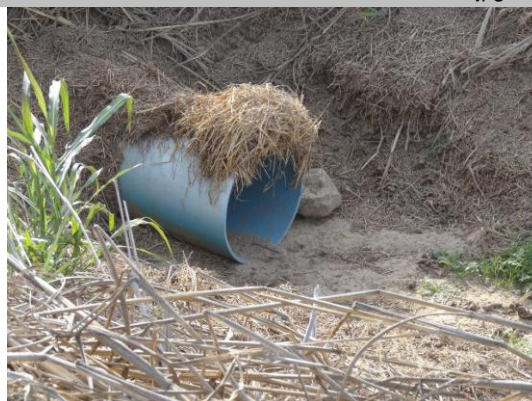
Photo 2 of 3 : UCIP_FA_2018_53095_43989.jpg

Comment Code						
Inspector Comment						
FS_ID:53095 DS_ID:22074 EP_NO: N/A Repair Type: Urgent Crossing Status: Found UCIP Comments: 10/19/2018 Pipe size was field measured and confirmed to be 16 inches. Unable to find any records indicating authorization for this crossing. This crossing appears to be an unauthorized encroachment. Need to contact owner to find out if crossing was authorized through the CVFPB. Surface erosion appears to have gotten worse since last inspection. Levee height at this crossing location is about 5 to 6 feet tall. Outstanding issues that need to be addressed with the CVFPB and owner for this crossing include: crossing appears to an unauthorized encroachment through the levee and surface erosion has increased on LS slope. Crossing remains Urgent due to the increase surface erosion on the LS. (O. Magana - DWR UCIP)09/29/2017 Received updated photos from DWR levee inspector, D. Torres, and photos show a metal cover has been added to landside (LS). The waterside (WS) pipe side remains open. This crossing remains urgent due to the WS end of the pipe open. Other issues with this crossing include compliance issues per Title 23. No permit was found authorizing this crossing. (DWR UCIP - O. Magana)08/23/2016 Same as last inspection. Recommend LMA contact owner to bring crossing into compliance per Title 23. (K. Fazel - UCIP)11/06/2013 Pipe opens on both sides of the levee. (P. Amatya - DWR) FIELD_STRUCT_DESC: 16-inch polyvinyl chloride (PVC) gravity drainage pipe through the levee, 3.5 feet below the crown. Pipe open on both ends. This crossing was field discovered. FS Date: 10/19/2018 11:00:00 AM

LS view: PVC pipe with open end on levee toe.

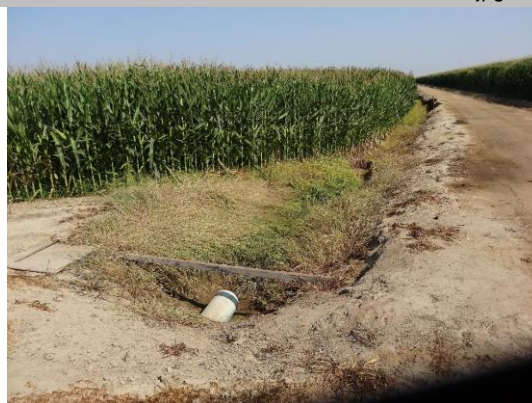
Photo 3 of 3 : UCIP_FA_2018_53095_76005.jpg

LS view of crossing

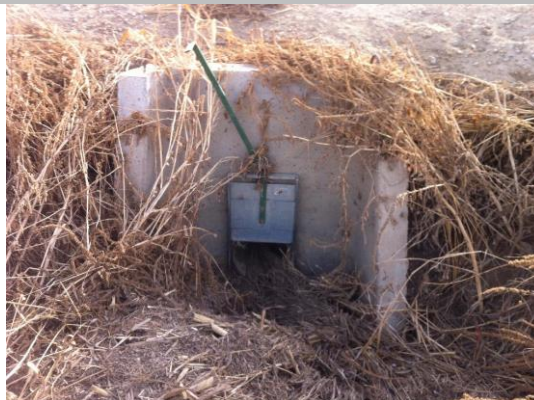
Photo 1 of 3 : UCIP_FA_2018_53096_43993.jpg

UCIP Comments: 10/19/2018 Pipe size was field measured and updated to a 12-inch pipe instead of an 8-inch pipe as previously reported. Additional notes found in permit file indicate that a 10-inch to 12-inch corrugated metal pipe (CMP) was authorized in 1976 and a USACE letter showed no objection for approval of Application No. 11631. Inspector's notes from 7/27/1976 indicate that a new 12-inch steel, coated and wrapped, with 6 feet of cover at the levee centerline was installed. This means that the 12-inch PVC is a pipe replacement. Need to contact owner to find out if the new pipe replacement was authorized through the CVFPB. Erosion is still visible on the LS slope near the concrete headwall. Levee height at this crossing location is about 6-feet tall. Unable to find the WS outlet due to dense vegetation. Need to address the following outstanding issues with the CVFPB and the owner for this crossing: pipe replacement without proper CVFPB documentation, dense vegetation on the WS slope, and erosion is still present on the LS toe near the headwall. Crossing remains Urgent due to the LS erosion behind the headwall. (O. Magana - DWR UCIP)

09/29/2017 Received updated photos from DWR levee inspector, D. Torres, and photos show erosion behind wing wall on LS and WS pipe end still remains opened. Pipe still needs to conform with Title 23. Crossing has been upgraded from Non-Urgent to Urgent, crossing remains opened on the WS. Unable to find permit authorizing pipe replacement through the levee. (DWR UCIP - O. Magana)

LS view: U type concrete headwall, slide gate, and pipe on levee toe.

08/23/2016 Same as last inspection. Pipe looks to be relatively newer than 1976. Appears there is no permit for this newer PVC pipe so recommend LMA contact owner to bring crossing into compliance with Title 23. Crossing has been upgraded from No Action Needed to Non-Urgent. (K. Fazel - UCIP)11/05/2013: Pipe not visible on waterside. Dense vegetation on waterside. (P. Amatya - DWR)

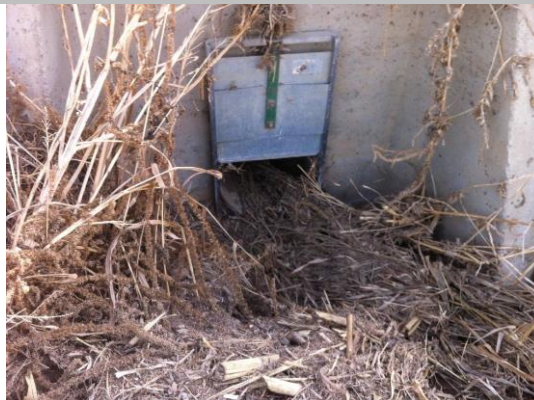
Photo 2 of 3 : UCIP_FA_2018_53096_43992.jpg

FS_ID:53096
DS_ID:24731
EP_NO: 11631
Repair Type: Urgent
Crossing Status: Found
UCIP Comments: 10/19/2018 Pipe size was field measured and updated to a 12-inch pipe instead of an 8-inch pipe as previously reported. Additional notes found in permit file indicate that a 10-inch to 12-inch corrugated metal pipe (CMP) was authorized in 1976 and a USACE letter showed no objection for approval of Application No. 11631. Inspector's notes from 7/27/1976 indicate that a new 12-inch steel, coated and wrapped, with 6 feet of cover at the levee centerline was installed. This means that the 12-inch PVC is a pipe replacement. Need to contact owner to find out if the new pipe replacement was authorized through the CVFPB. Erosion is still visible on the LS slope near the concrete headwall. Levee height at this crossing location is about 6-feet tall. Unable to find the WS outlet due to dense vegetation. Need to address the following outstanding issues with the CVFPB and the owner for this crossing: pipe replacement without proper CVFPB documentation, dense vegetation on the WS slope, and erosion is still present on the LS toe near the headwall. Crossing remains Urgent due to the LS erosion behind the headwall. (O. Magana - DWR UCIP) 09/29/2017 Received updated photos from DWR levee inspector, D. Torres, and photos show erosion behind wing wall on LS and WS pipe end still remains opened. Pipe still needs to conform with Title 23. Crossing has been upgraded from Non-Urgent to Urgent, crossing remains opened on the WS. Unable to find permit authorizing pipe replacement through the levee. (DWR UCIP - O. Magana)

LS view: closer view of U type concrete headwall, slide gate, and pipe on levee toe.

08/23/2016 Same as last inspection. Pipe looks to be relatively newer than 1976. Appears there is no permit for this newer PVC pipe so recommend LMA contact owner to bring crossing into compliance with Title 23. Crossing has been upgraded from No Action Needed to Non-Urgent. (K. Fazal - UCIP) 11/05/2013: Pipe not visible on waterside. Dense vegetation on waterside. (P. Amatya - DWR) FIELD_STRUCT_DESC: 12-inch polyvinyl chloride (PVC) gravity drainage pipe (field measured) through the levee, 4 feet below the crown. Metal slide gate in a concrete U-shaped headwall on the landside (LS). (Plans to install a 10-inch or a 12-inch drainage pipe through the levee and into project ditch on the riverbank authorized under Permit No. 11631, 1976 - A. W. Barcellos).
FS Date: 10/19/2018 11:09:00 AM

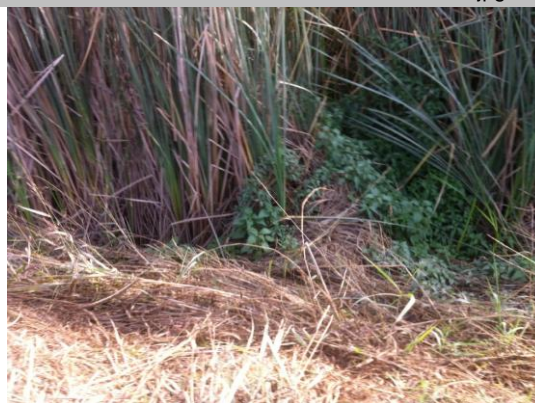
Photo 3 of 3 : UCIP_FA_2018_53096_43991.jpg

UCIP Comments: 10/19/2018 Pipe size was field measured and updated to a 12-inch pipe instead of an 8-inch pipe as previously reported. Additional notes found in permit file indicate that a 10-inch to 12-inch corrugated metal pipe (CMP) was authorized in 1976 and a USACE letter showed no objection for approval of Application No. 11631. Inspector's notes from 7/27/1976 indicate that a new 12-inch steel, coated and wrapped, with 6 feet of cover at the levee centerline was installed. This means that the 12-inch PVC is a pipe replacement. Need to contact owner to find out if the new pipe replacement was authorized through the CVFPB. Erosion is still visible on the LS slope near the concrete headwall. Levee height at this crossing location is about 6-feet tall. Unable to find the WS outlet due to dense vegetation. Need to address the following outstanding issues with the CVFPB and the owner for this crossing: pipe replacement without proper CVFPB documentation, dense vegetation on the WS slope, and erosion is still present on the LS toe near the headwall. Crossing remains Urgent due to the LS erosion behind the headwall. (O. Magana - DWR UCIP)

09/29/2017 Received updated photos from DWR levee inspector, D. Torres, and photos show erosion behind wing wall on LS and WS pipe end still remains opened. Pipe still needs to conform with Title 23. Crossing has been upgraded from Non-Urgent to Urgent, crossing remains opened on the WS. Unable to find permit authorizing pipe replacement through the levee. (DWR UCIP - O. Magana)

WS view: dense vegetation, no pipe visible.

08/23/2016 Same as last inspection. Pipe looks to be relatively newer than 1976. Appears there is no permit for this newer PVC pipe so recommend LMA contact owner to bring crossing into compliance with Title 23. Crossing has been upgraded from No Action Needed to Non-Urgent. (K. Fazal - UCIP)11/05/2013: Pipe not visible on waterside. Dense vegetation on waterside. (P. Amatya - DWR)
